The recent flooding across Queensland, Northern NSW and Western Victoria has caused loss of life and immense damage to properties. Understanding where to start in the rebuilding or reconstruction process can be difficult. As people now start to assess the damage to their homes, CSR appreciates the situation they may be in and in order to assist the process this bulletin will aim to provide corrective measures and relevant information relating to products which may have been affected. Your safety and understanding of what to do is our priority and this recommendation is based on dealing with plasterboard, fibre cement, insulation, glass, bricks and roofing products.

Before the work begins – things to consider...

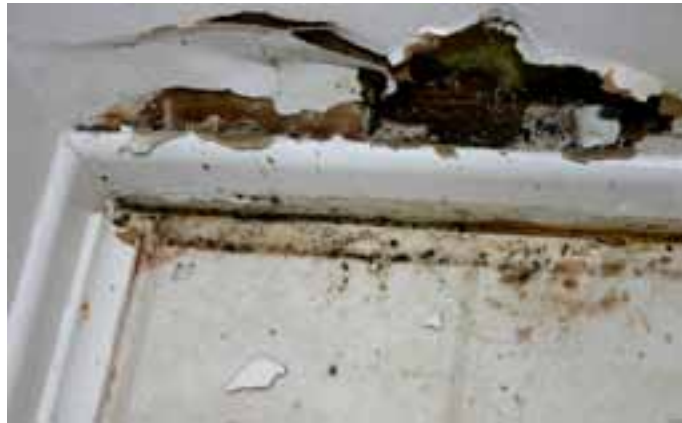
- Where flood water has risen up walls, it is important to drain any water from the cavities. Skirting boards need to be removed and holes drilled above the bottom plate, or if you have metal stud walls then they are removed by drilling through the channel at floor level. If water is present in the cavities then cut a hole which is large enough to drain the water. To ensure all water is completely drained, this process must be repeated at each cavity. If the wall cavity has insulation material in it and this is wet, then the lining on at least one side of the wall will need to be removed to take the wet insulation out.

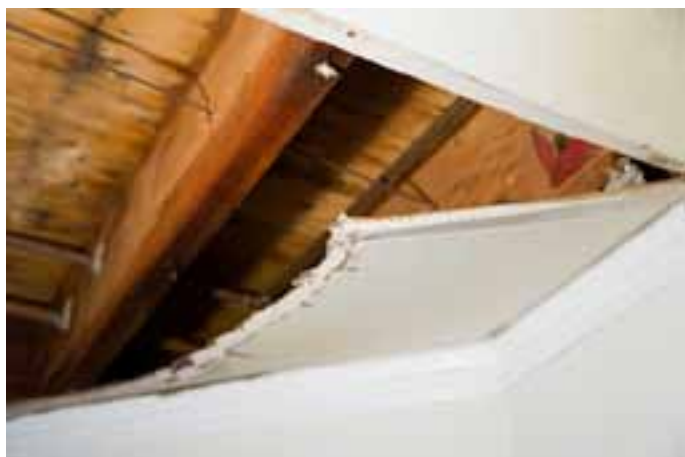
- Almost all ceilings that have been inundated will need to be replaced (especially where absorbent insulation is involved) as water will likely have ponded for too long a period and all the fixings will be compromised.

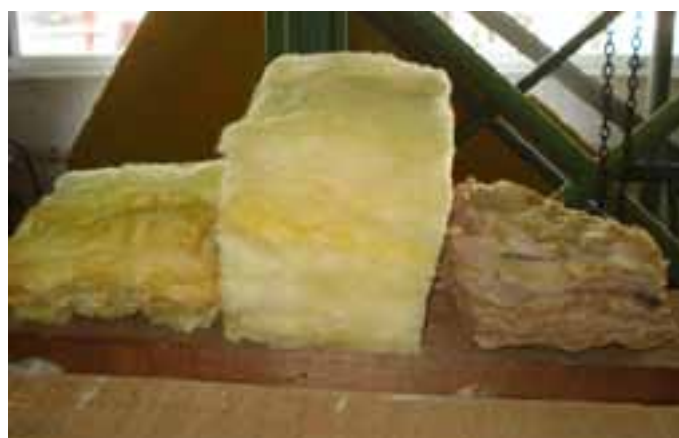
- If the insulation has been completely saturated then it will be required to be replaced. If the insulation has been completely saturated and then dried out, it may not recover to its original thickness and its thermal performance will be significantly reduced.
- On the other hand if the insulation is only slightly wet due to something like minor leakage through the roof and then it can be removed, dried out and reused.

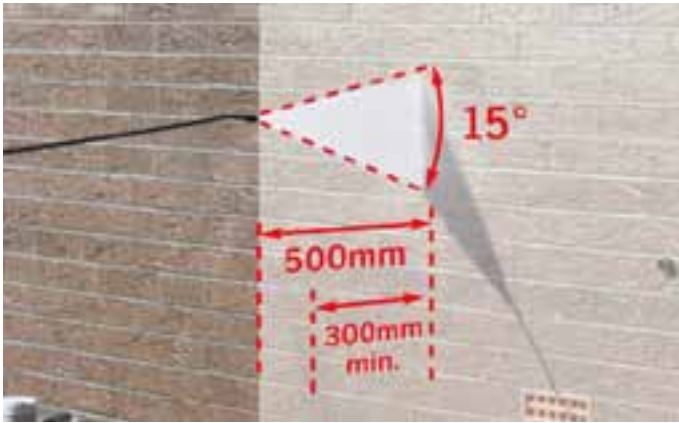
5. A straight or zero degree water jet should never be used. A spray angle of 15 degrees, called a fan jet, will allow the operator to concentrate the pressure on the bricks and not on the joints. (Shown above)
6. The jet should generally be 500mm from the wall and never closer than 300 mm for localized patches.

1. Masks and other protective clothing should be worn whilst cleaning.
2. Any non fixed or adjacent materials such as loose metal, glass and wood should be removed prior to commencing.
3. Wash the wall with a high pressure water hose or gurney from top to bottom so all dissolved mortar particles will be completely flushed from wall surfaces.
4. The maximum pressure of the pump should be kept low, around 7000 to 8000 kPa (1000 to 1200 psi), to prevent damage to either the masonry units or the mortar. The concentration of power with which the water jet strikes the wall is a function of the flow in the hose, the pressure, the type of nozzle and the distance from the nozzle to the wall.
